DEEP FOUNDATIONS

Alberta Makes Peace with Highway Landslides

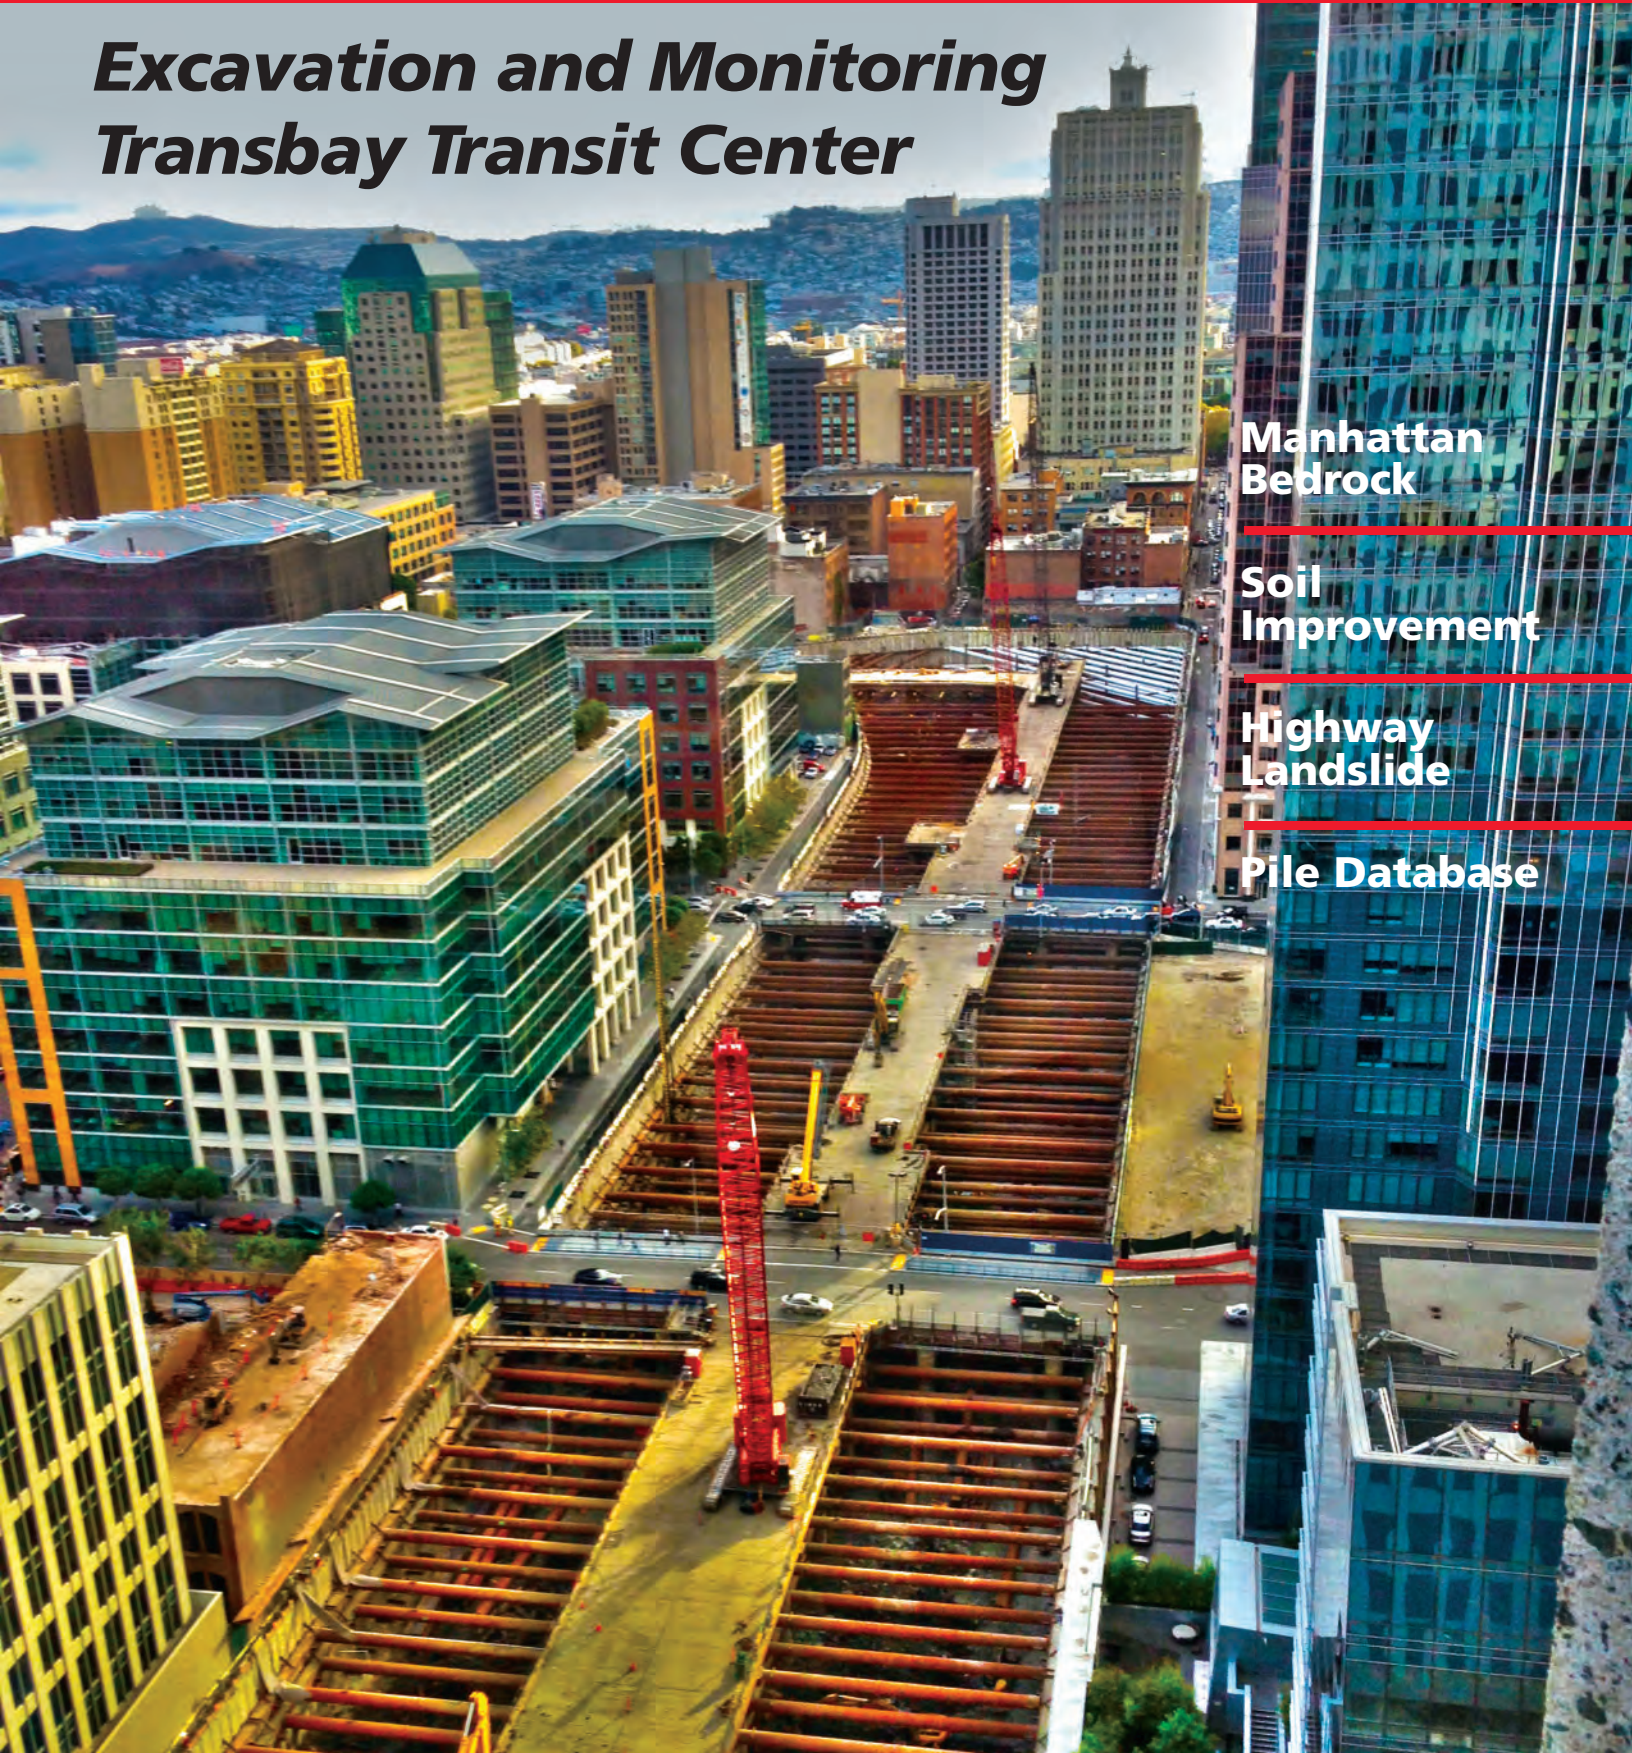
asphalt. Both lanes of the highway continued to rapidly deteriorate, developing open horizontal gaps up to 250 mm (9.8 in) wide, vertical drops up to 300 mm (11.8 in) deep and the protrusion of previously installed large stone columns upwards through the existing pavement structure. Alberta Transportation closed the road due to safety concerns on May 17. By May 21, large sections of the highway had completely collapsed due to the shifting earth underneath the roadbed.

Sunshine slide caused large sections of Judah Hill Road to collapse (courtesy of Alberta Transportation)

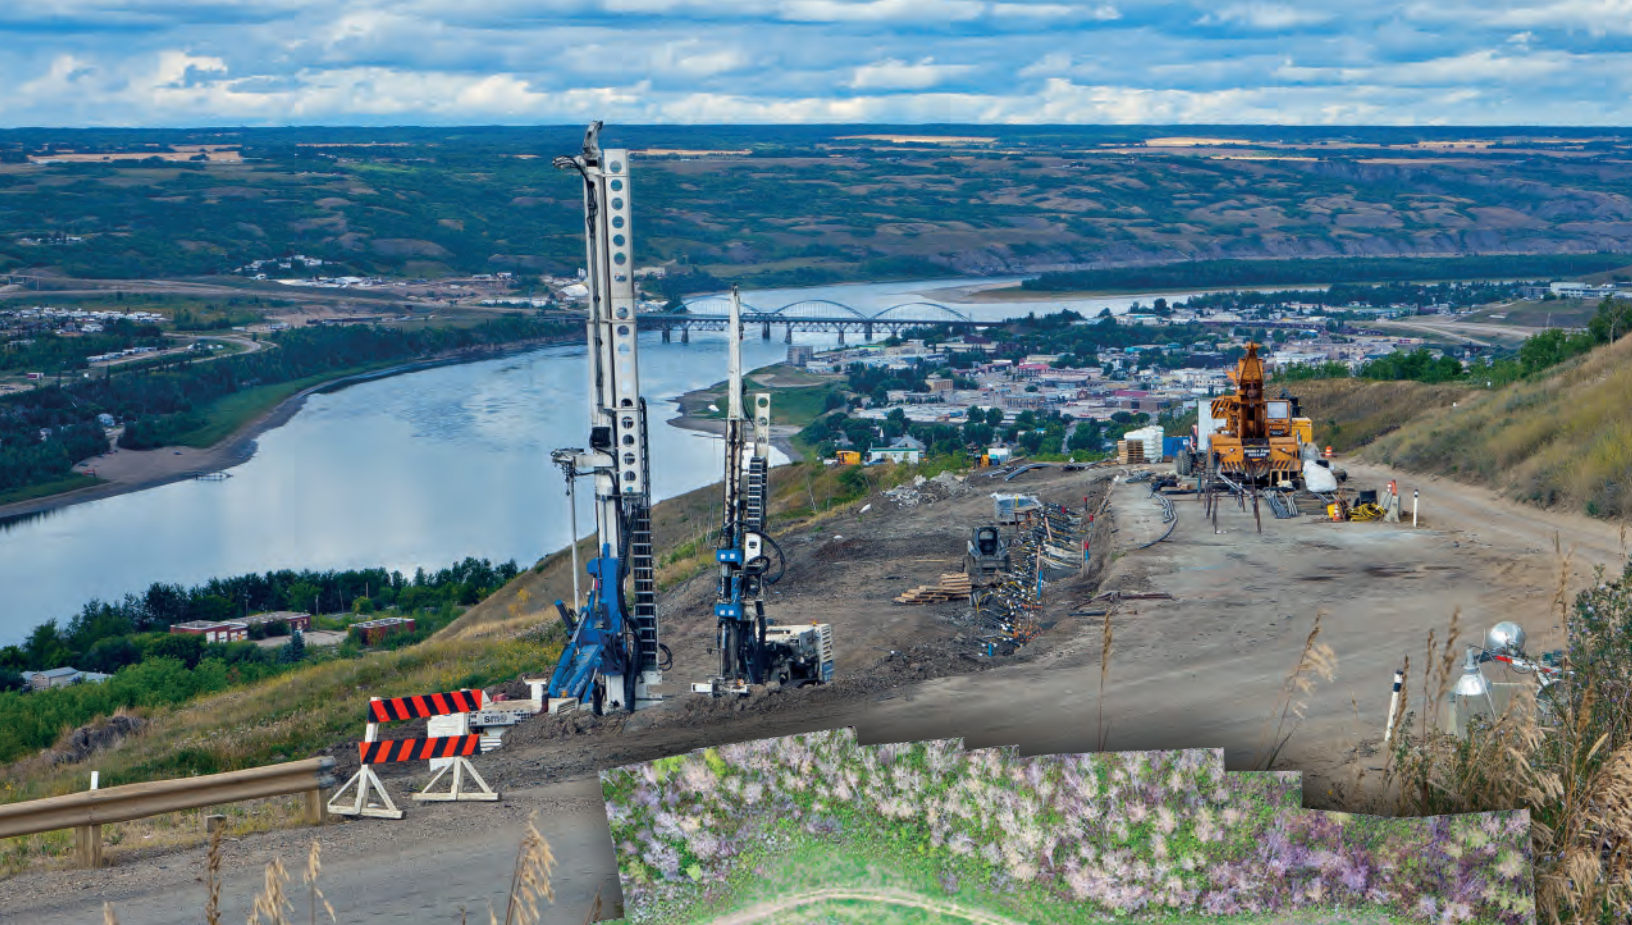
Work underway in an active landslide area
(courtesy of Doublestar Drilling)

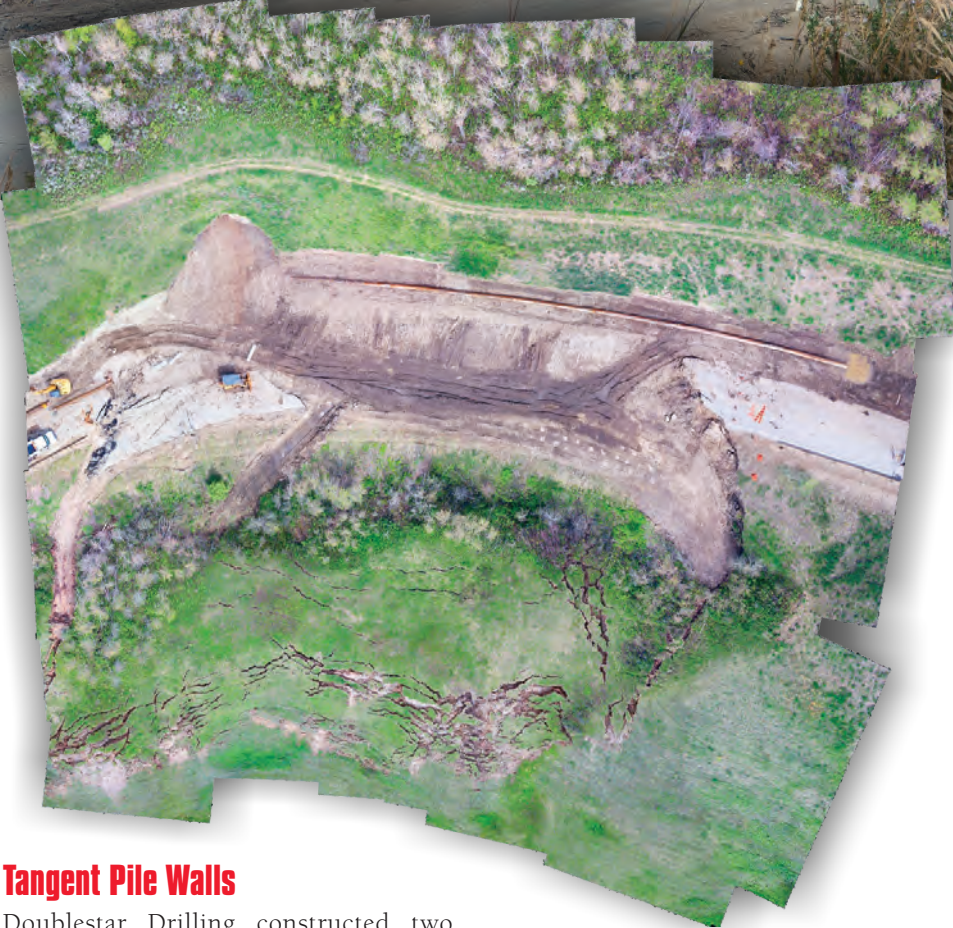
Composite aerial photo of the landslide area
(courtesy of Queen's University, Kingston, Ontario)

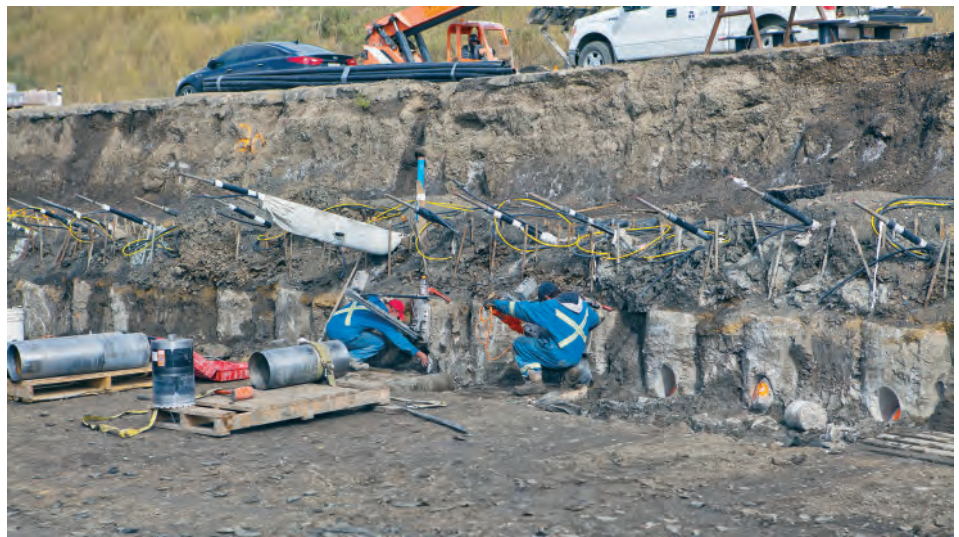
Two rows of tiebacks installed at 25 and 30 degrees to horizontal (courtesy of Doublestar Drilling)

For the first tangent pile wall, a total of 216 tieback anchors were installed in two rows. The upper row of anchors were tensioned and locked off 0.35 m (1.1 ft) below the top of the waler and inclined at 25 degrees to horizontal. The lower row of anchors were tensioned and locked off 1.05 m (3.4 ft) below the top of the waler and inclined at 30 degrees to horizontal. The upper row of anchors extended 40 m (131 ft) and the lower row of anchors extended 35 m (115 ft) from the centerline of the piles.

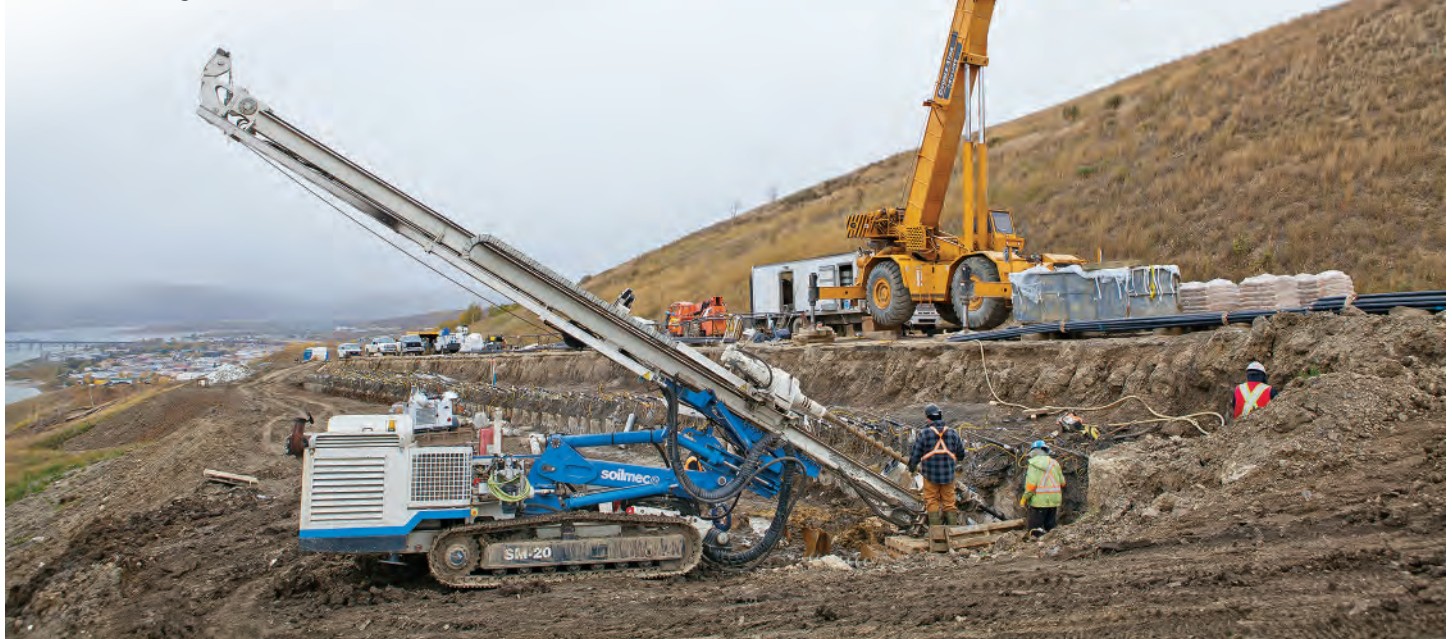
Soilmec SM-20 rig installing ground anchors on a sloping hillside (Courtesy of Doublestar Drilling)
