PILING CANADA

TAMING

KICKING HORSE CANYON

Work recently wrapped
at Kicking Horse Canyon
improving safety on a risky
21-kilometre stretch of the
Trans-Canada Highway

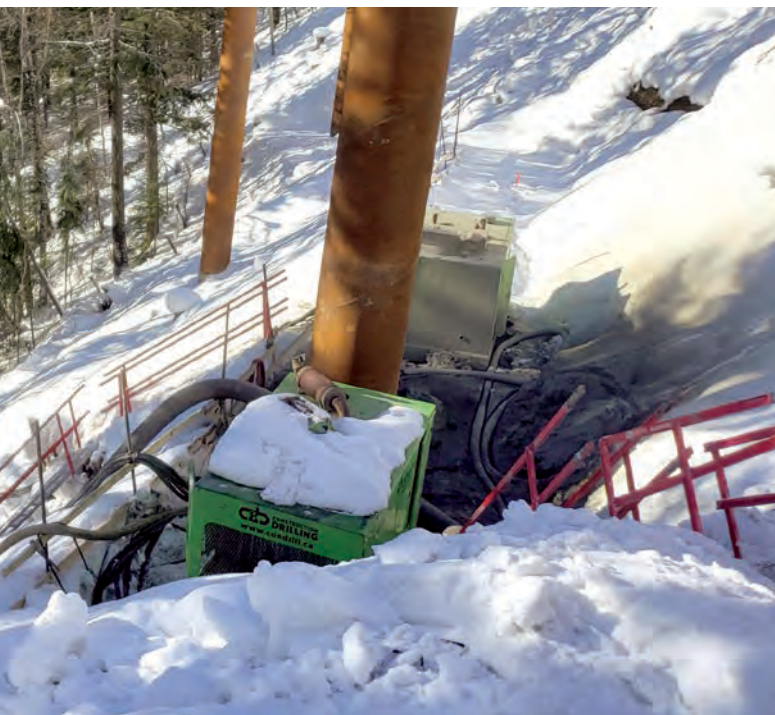
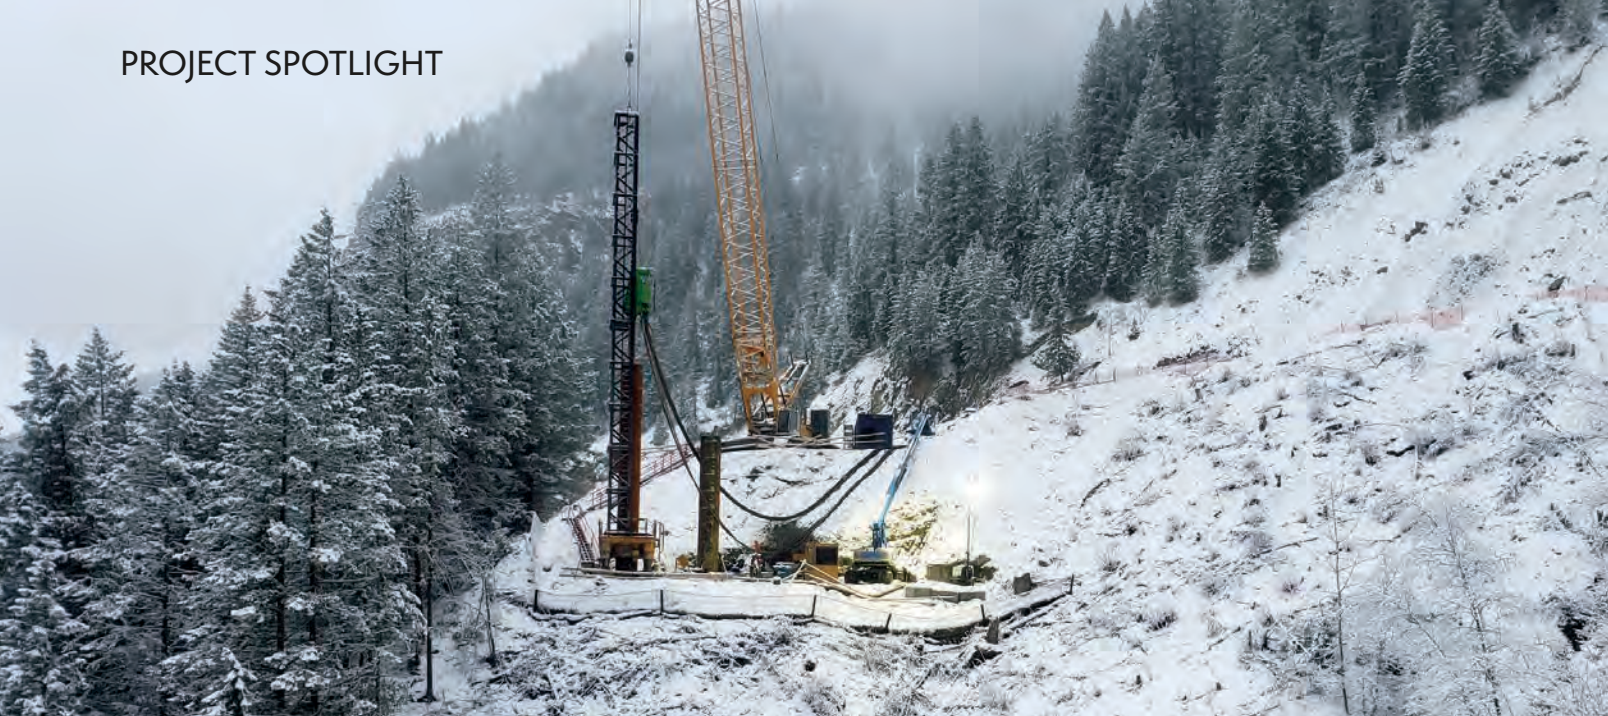
Given the high alpine terrain and variable weather conditions, maintaining a safe worksite was paramount throughout the course of the project.
