DEEP FOUNDATIONS

Alberta Makes Peace with Highway Landslides

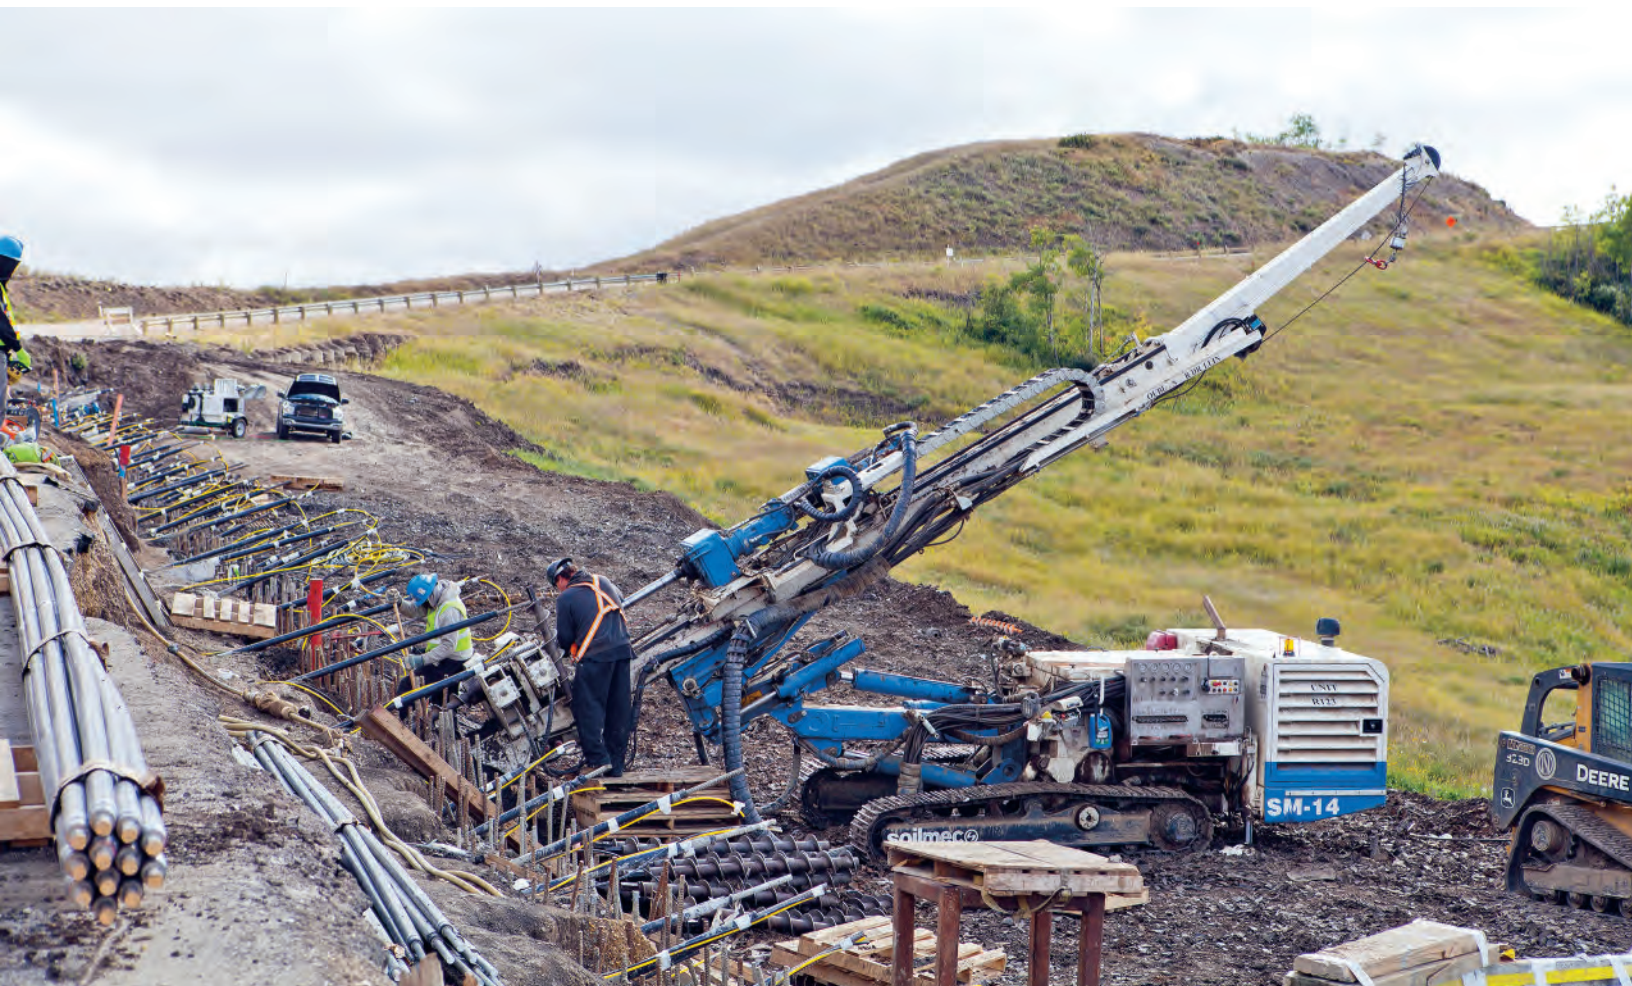
Soilmec SM-14 microdrilling rig (courtesy of Doublestar Drilling)

Double-corrosion protected, 32 mm (1.3 in) threaded bars were inserted into the holes above and through the tangent walls, and then the holes were filled with high-strength grout. Multiple stages of post grouting were required for this anchor installation to eliminate voids. The lengths

of threaded bar above the bond zone were also covered by bond breakers to eliminate load transfer above the bond zone.
