Alberta Makes Peace with Highway Landslides

On Judah Hill Road, tied-back tangent pile walls stabilized the landslide mass and anchored the remaining strata

By Tyler Wilbur, Doublestar Drilling, and Craig Berninger, Champion Equipment Sales and Soilmec North America

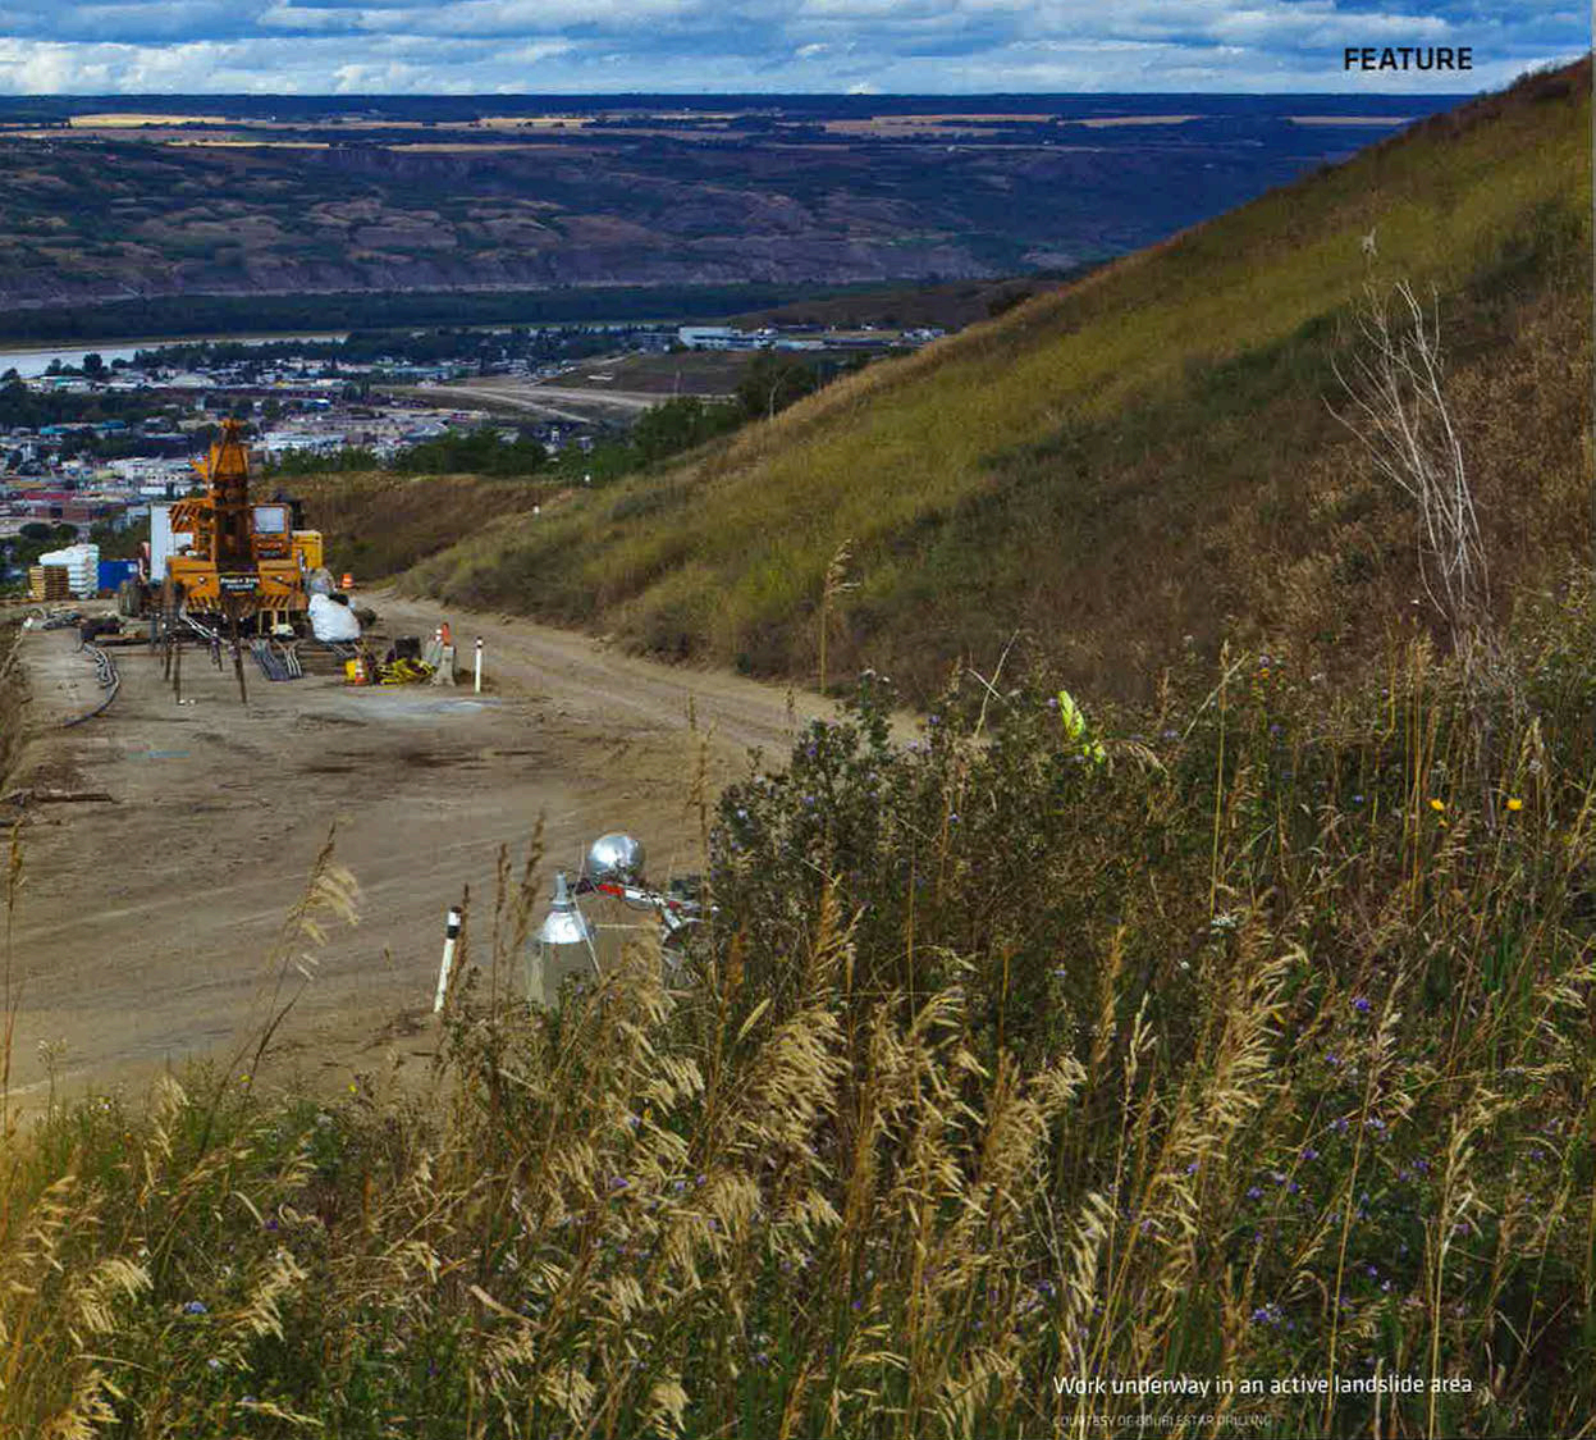
Work underway in an active landslide area

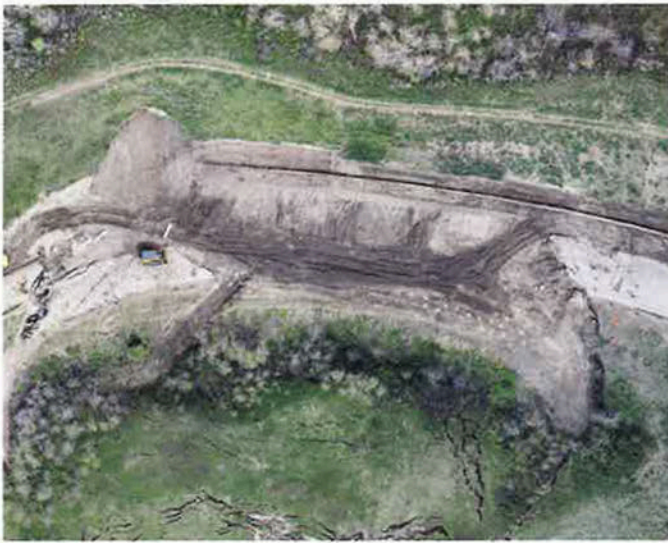
Composite aerial photo of the landslide area

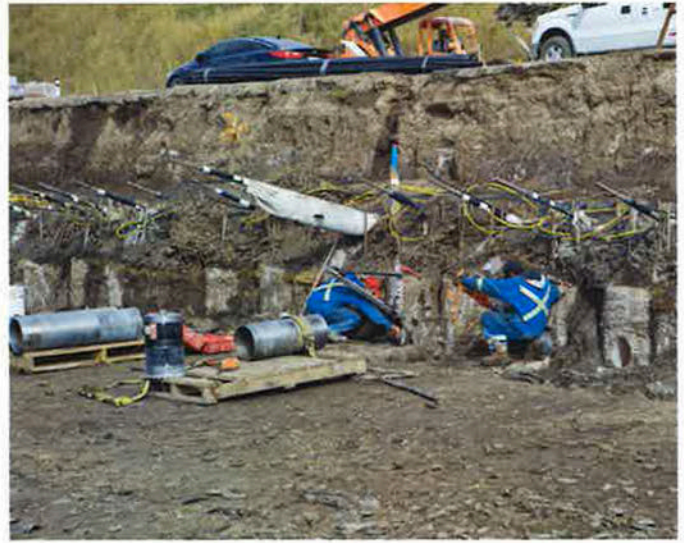
Two rows of tiebacks installed at 25 and 30 degrees to horizontal

For the first tangent pile wall, a total of 216 tieback anchors were installed in two rows. The upper row of anchors were tensioned and locked off 0.35 metres below the top of the waler and inclined at 25 degrees to horizontal. The lower row of anchors were tensioned and locked off 1.05 metres below the top of the waler and inclined at 30 degrees to horizontal. The

Similarly, three rows of tiebacks were installed in the second tangent pile wall: the upper row at 23 degrees, middle row at 28 degrees and lower row at 32 degrees to horizontal. A total of 322 anchors were installed in this second tangent wall. These anchors were spaced 0.5 metres apart, each providing a design load of 192 kN (43 kip) that supplemented the design load of about 250 kN (56 kip) provided by the pile wall.

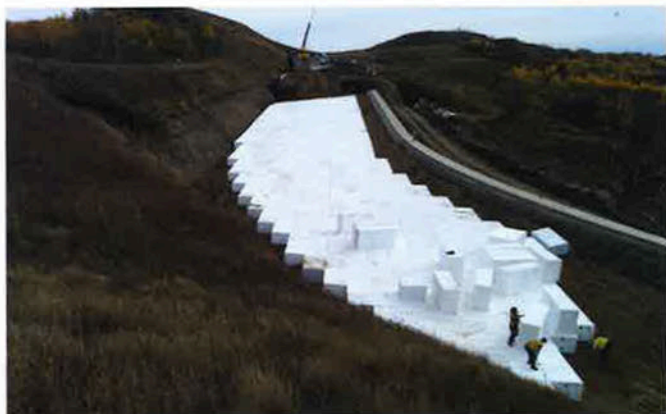
Three layers of expanded polystyrene geofoam blocks were used as backfill to reconstruct the highway embankment and reduce the soil pressure on the walls

As a long-term solution, tied-back tangent pile walls were selected as the best remediation method to stabilize the landslide mass and anchor the remaining strata. Two tied-back walls were constructed about 300 metres apart from each other just below the damaged sections of highway. Both walls were installed by Doublestar Drilling using Soilmec SM-14, SM-20 and SR-30 rigs. Once the walls were complete, three layers of expanded polystyrene geofoam blocks were used as

backfill to reconstruct the highway embankment and reduce the soil pressure on the walls.

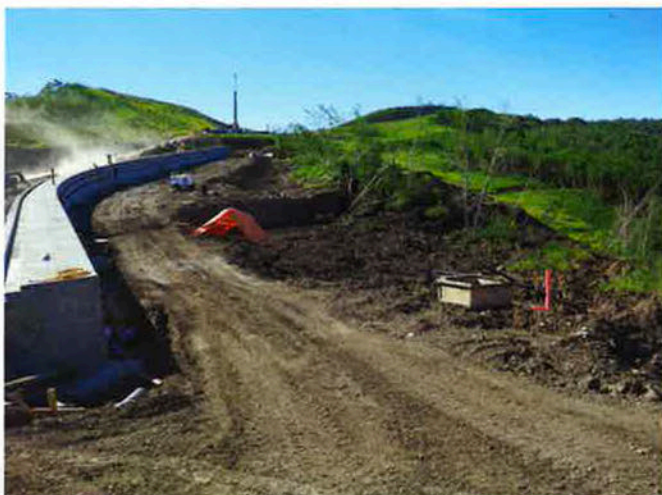
These 2.2-metre-thick concrete walers were used to secure all tieback anchors and transfer loads evenly

A continuous, reinforced concrete waler or pile cap was then installed along the top of each continuous tangent pile wall. These 2.2-metre-thick concrete walers were used to secure all tieback anchors and transfer loads evenly.

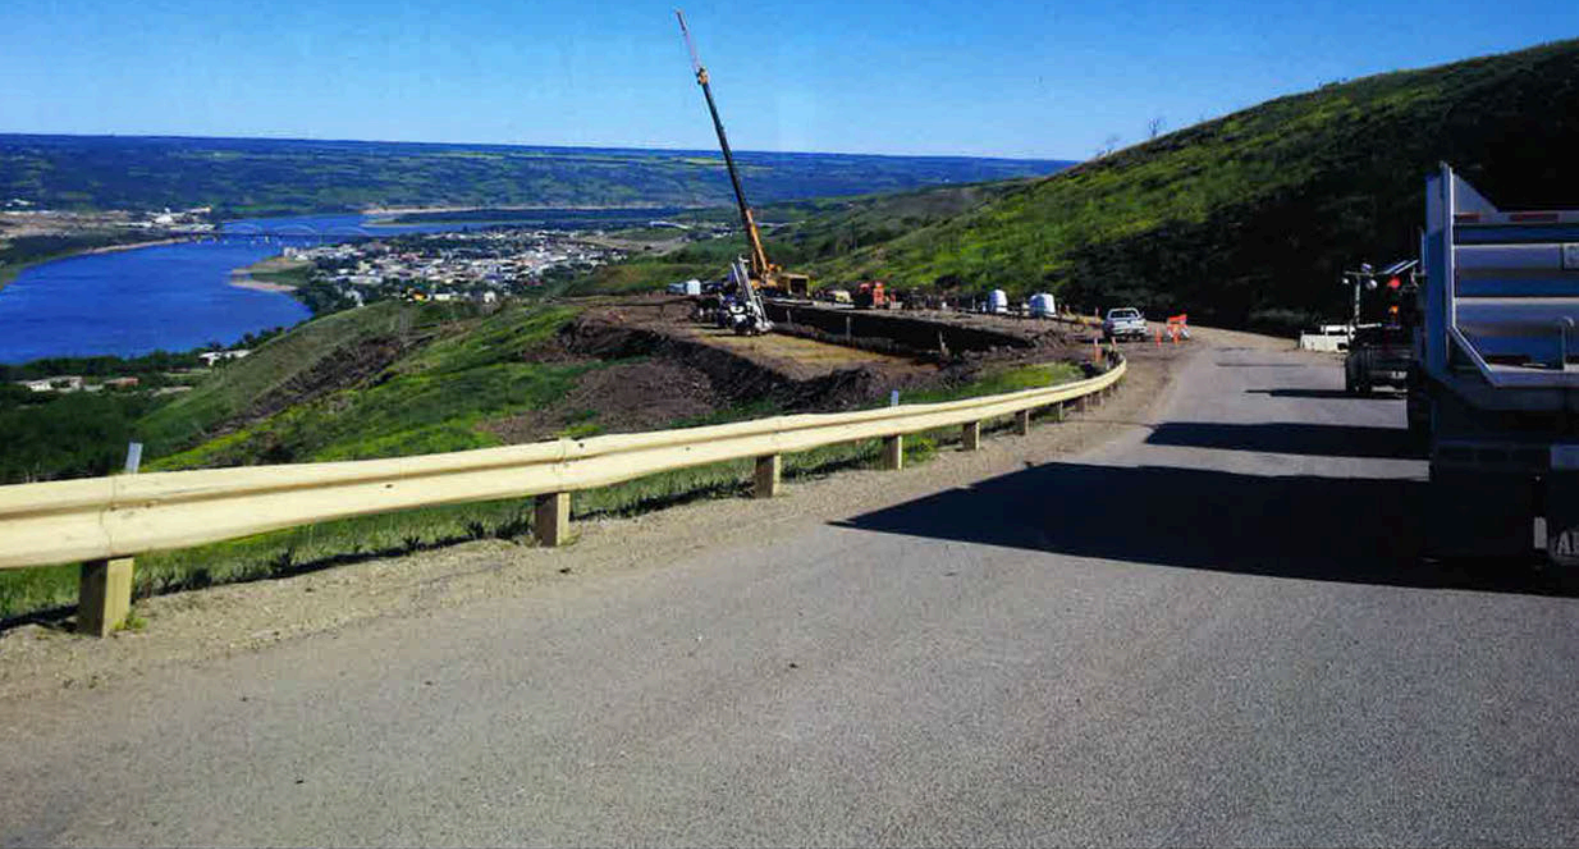
Soilmec SM-20 rig installing ground anchors on a sloping hillside

Ground anchors were also required to supplement the shear resistance provided by the piles. The anchors were bonded deep into the ground behind the failure plane, beyond where any future landslide activity was expected to originate. Doublestar Drilling used two Soilmec SM-14 microdrilling rigs and one Soilmec SM-20 anchoring rig to meet the geotechnical design requirements.
